J. Serb. Chem. Soc. 90 (11) 1383–1399 (2025)
JSCS–5460

Investigation of corrosion causes and failures in the interior metal components of an automobile

Abstract: The extent of corrosion and the underlying causes of damage to the interior metal components of a one-year-old automobile from a known brand, owned by a rental car company in Serbia, were investigated. The vehicle's interior, including upholstery and carpeting, showed no chemical spills or other damage. The solution obtained after rinsing a carpet sample from the car floor exhibited neutral pH. The corrosion behavior of the analyzed samples was determined using electrochemical impedance spectroscopy (EIS), linear polarization resistance (LPR) and linear sweep voltammetry (LSV, Tafel method). X-ray diffraction (XRD) and Fourier-transform infrared spectroscopy (FTIR) analyses showed that corrosion products taken from corroded steel parts contain akaganeite β -FeO(OH) and iron (II) chloride. FTIR analysis of the organic coating revealed that the applied epoxy layer was insufficiently crosslinked, making it permeable to moisture and chloride ions. Electrochemical corrosion measurements on steel with a similar chemical compos

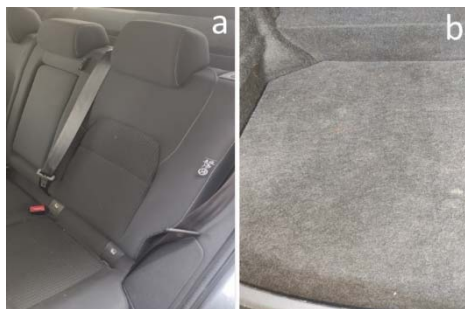
A detailed visual inspection of the automobile interior was carried out, and appropriate photographs were taken. The automobile interior looked new and preserved without any visible mechanical or other failure. Fig. 1a shows the exterior view of the automobile's back seat. There is no noticeable damage on the upholstered parts of the rear bench and the upholstery looks brand new. The carpet on the automobile floor also seems to be preserved, without damage. The carpet in the trunk was clean completely and undamaged as well (Fig. 1b). There are no traces of liquid spillage (water stains, aggressive liquids, etc.), nor visible external damage to the carpet in the trunk.

Fig. 1. Exterior view of: a) the back seat of the car and b) the carpet in the automobile trunk.

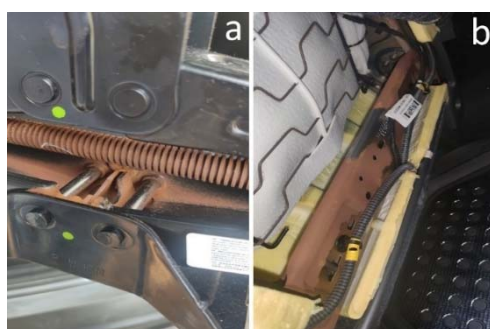
However, corrosion was observed on various metal components located in the double bottom of the automobile trunk. Specifically, the metal parts around the spare wheel exhibited corrosion, and the towing hook was completely corroded.

Significant corrosion was also evident on the automobile jack (Fig. 2a), with the surfaces of these components entirely coated in characteristic yellow–brown to brown corrosion products. Upon removing the seat upholstery, corrosion was found on the seat frame and axle, similarly covering their entire surfaces (Fig. 2b). Notably, the sponge and seat material showed no signs of water stains, chemical residue, or other liquids that might have contributed to the corrosion of these metal parts; they appeared undamaged and well-preserved.

Fig. 2. Corrosion of: a) the automobile jack components and b) the frame and shaft inside.

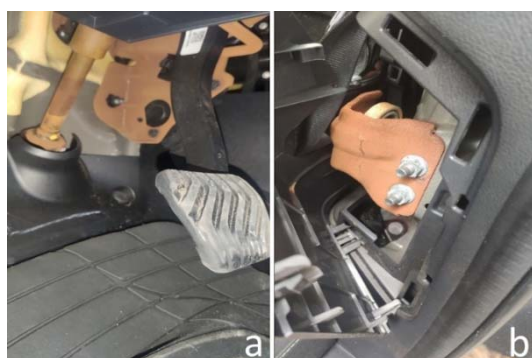
Beneath the dashboard, behind the control pedals, extensive corrosion of several metal components was evident (Fig. 3a). These parts were entirely covered with the characteristic yellow–brown to brown corrosion products. Lifting the protective cover on the rear seat revealed similarly complete corrosion on some metal components (Fig. 3b). Galvanized screws were used to fasten the protective covers. Zinc is expected to corrode preferentially, thereby protecting the steel from corrosion. However, the steel components exhibited extensive corrosion while the zinc coating on the screws remained intact.

Fig. 3. Corrosion of: a) the steel components under the control panel and b) the steel parts under the protective mask on the rear seat.

When steel objects lack adequate corrosion protection, they corrode much faster than galvanized screws. Thus, under the prevailing corrosive conditions, the

zinc coating effectively protected the screws, but it was insufficient to prevent corrosion of the surrounding steel parts.

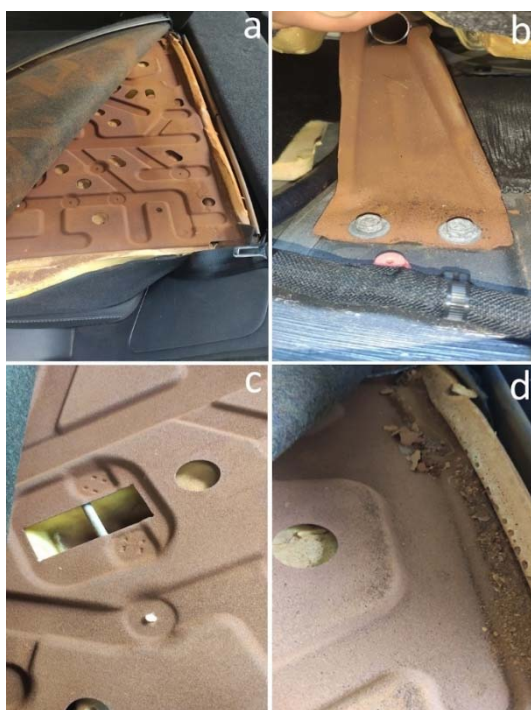
Building upon the previously observed corrosion patterns, Fig. 4 further illustrates instances of corrosion failure on steel parts within the automobile's interior. The surfaces of these components are entirely covered in characteristic yellow-brown to brown steel corrosion products, consistent with previous findings. Notably, Fig. 4d reveals significant corrosion along the edges of a corroded steel part, along with layers of powdery steel corrosion products, suggesting that the corrosion process occurred over an extended period.

Fig. 4. Corrosion of steel parts.

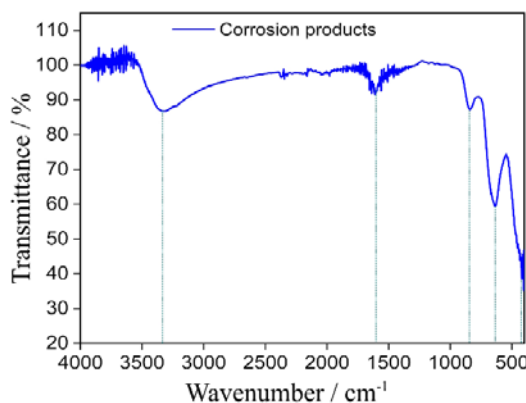
FTIR analysis of the corrosion products (Fig. 5) revealed characteristic peaks at 3348 and 1614 cm^{-1} , corresponding to asymmetric and symmetric O–H stretching vibrations, respectively. Additionally, bands observed at 844 and 639 cm^{-1} can be attributed to –OH bending modes, indicative of the presence of $\beta\text{-FeOOH}$.^{29–32} The presence of chloride ions in the corrosion products can be observed based on the base peak at the 420 cm^{-1} wavelength, which originates from an acid chlorides in-plane deformation.³³

Fig. 5. FTIR diagram of steel corrosion products.

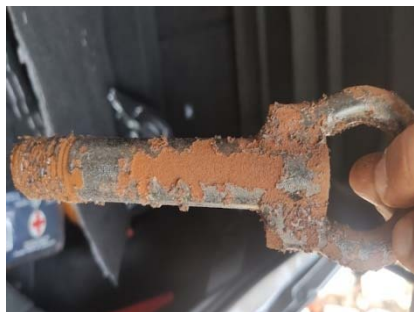
Given the extensive corrosion observed on the steel components, assessing the thickness and adhesion of the original organic coating proved challenging. On many components, the coating was absent, while on others, it was peeling away from the metal surface (Fig. 6). As a result, our analysis focused on determining the composition of the remaining coating fragments using FTIR spectroscopy.

Fig. 6. Appearance of the applied organic coating (paint) on the surface of the towing hook.

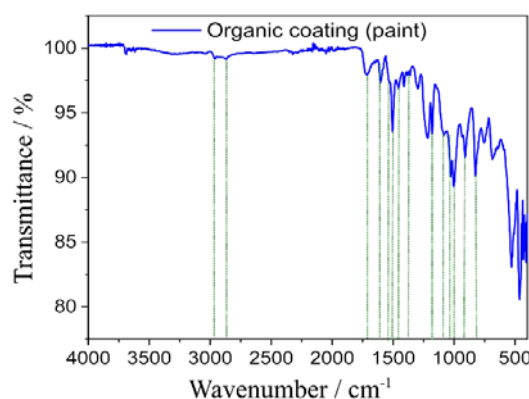
Fig. 7 shows the characteristic peaks obtained during the examination of the organic coating by the FTIR method. The organic coating contains a series of peaks corresponding to aromatic and aliphatic organic compounds, as well as an epoxy group, which is present in epoxy coatings.³⁴

Fig. 7. Characteristic peaks obtained during the examination of the organic coating by the FTIR method.

The non-crosslinked epoxy coating (paint) has two characteristic peaks, which indicate the presence of the epoxy group: the first peak is located in the range of wavelengths from 3060 to 3000 cm^{-1} , while the second peak is located in the range of wavelengths from 960 to 810 cm^{-1} and it refers to the C–O deformation of the epoxy group.^{35–39} The presence of peaks at 910 and 826 cm^{-1} wavelengths on the FTIR diagram (Fig. 7) indicates that the epoxy coating was not properly crosslinked. However, the absence of peaks in the range of wavelengths from 3060 to 3000 cm^{-1} is a sign that the epoxy coating is still partially crosslinked.^{35–39}

The inadequate cross-linking of the epoxy coating can be attributed to an improper curing process, such as curing at insufficiently high temperatures and/or for an inadequate duration. This incomplete crosslinking results in a porous coating, allowing chloride ions and moisture to penetrate through the pores, thereby creating favorable conditions for corrosion to occur. Additionally, the poorly crosslinked epoxy coating is brittle, making it prone to peeling from the steel surface. The weak adhesion of the coating may also stem from inadequate surface preparation or cleaning of the steel components before the application of the coating. These factors collectively explain the observed condition of the organic coating in the automobile and its inability to provide effective corrosion protection.

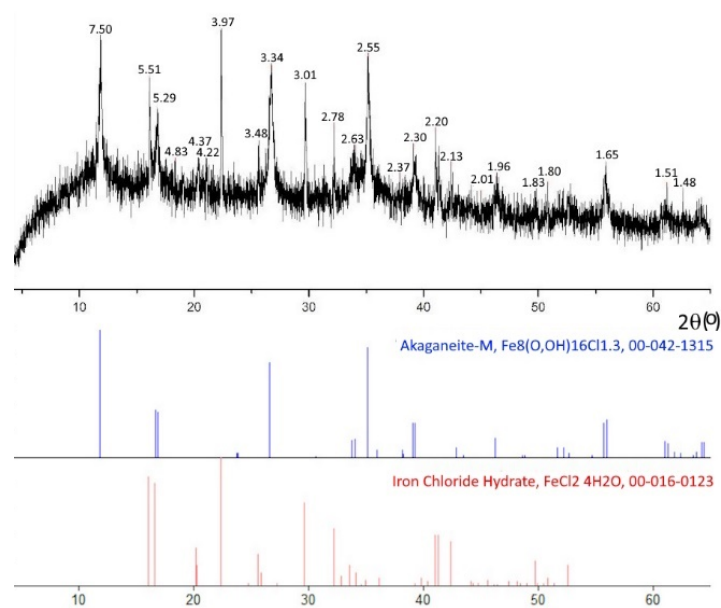
The XRD analysis of the corrosion products collected from the automobile (Fig. 9) identified two crystalline phases: β -FeO(OH) (ferric oxy-hydroxide) and $\text{FeCl}_2 \cdot 4\text{H}_2\text{O}$. Semi-quantitative analysis showed that β -FeO(OH) accounted for approximately 88 wt. % of the corrosion products, while $\text{FeCl}_2 \cdot 4\text{H}_2\text{O}$ made up about 12 wt. %. The β -FeO(OH), also known as akaganeite, crystallizes in a monoclinic structure within space group I2/m (No. 12). Literature indicates that akaganeite requires chloride ions to stabilize its structure, with its formula more accurately represented as $\text{FeO}_{0.833}(\text{OH})_{1.167}\text{Cl}_{0.167}$.⁴¹ In its structure, octahedral chains form tunnels that are partially filled with chloride ions, occupying approximately two-thirds of the available sites. Hydrogen bonds between chlorides and surrounding hydrogen further stabilize the structure. At temperatures above 200 °C, akaganeite releases chloride ions and transforms into hematite Fe_2O_3 , a more stable phase. The crystal structure and microstructure of akaganeite have been extensively documented in the literature.^{21,22,42}

The identified phases are characteristic of steel corrosion under humid conditions with significant chloride ion presence. Akaganeite is commonly associated with active corrosion processes, while iron (II) chloride hydrate plays a role in sustaining these processes. In environments with lower chloride concentrations, alternative corrosion products such as goethite, lepidocrocite or misawite are typically formed, which tend to slow down steel corrosion compared to akaganeite. Thus, the presence of akaganeite in the analyzed sample indicates ongoing active

corrosion and suggests that the corrosive processes have persisted for a considerable period.

Fig 9. Diffractogram of the examined sample of corrosion products.

The non-properly crosslinked epoxy coating on the steel surface further facilitated corrosion. Its porous and brittle nature allowed moisture and chloride ions to diffuse through to the steel surface, initiating and sustaining the Askey cycle.⁴³ This continuous regeneration of hydrogen and chloride ions promotes an acidic environment conducive to active corrosion. Only complete drying of the corrosion products, including akaganeite and iron (II) chloride hydrate, can disrupt this cycle and stop further degradation.

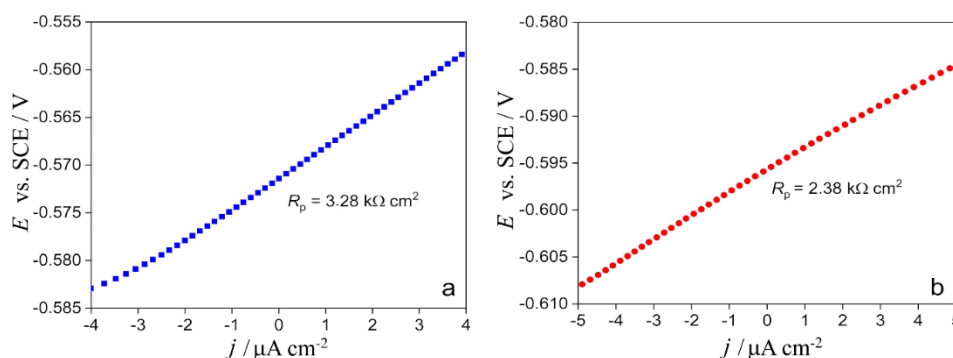
Linear polarization resistance (*LPR*) measurements were conducted to assess the corrosion resistance of steel in different solutions, and the results are presented in Fig. 10. As can be seen from Fig. 10, the polarization resistance (R_p) for steel in the solution containing corrosion products was $2.38 \text{ k}\Omega \text{ cm}^2$, while the R_p for steel in the standard solution was $3.28 \text{ k}\Omega \text{ cm}^2$.

Fig. 10. Results of the *LPR* testing in: a) standard solution and b) solution obtained by dissolving corrosion products in the standard solution.

Therefore, *LPR* measurements indicated that the standard solution exhibited a higher R_p than the solution with dissolved steel corrosion products. This suggests that the corrosion products, which contain akaganeite ($\beta\text{-FeO(OH)}$) and iron (II) chloride, release hydrogen ions according to Reaction (4), creating a moderately acidic environment. It is well-established that the corrosion rate of steel is higher in acidic environments compared to neutral ones, which explains the lower R_p value observed in the solution containing corrosion products.

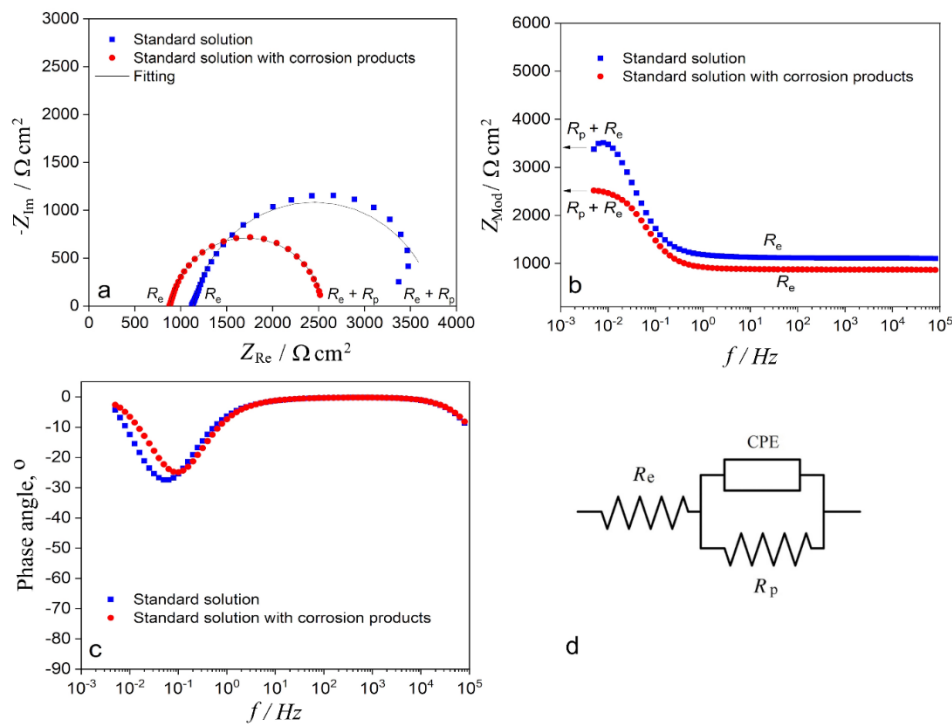
The polarization resistance values obtained from the EIS measurements, based on both the Nyquist and Bode modulus diagrams (Fig. 11), revealed that the R_p value for steel in the solution containing dissolved corrosion products was 1.67 $\text{k}\Omega \text{ cm}^2$, while in the standard solution it was higher, at 2.64 $\text{k}\Omega \text{ cm}^2$.

Fig 11. Results of the EIS test in the standard solution and in the standard solution in which corrosion products are dissolved; a) Nyquist diagrams, c) Bode modulus diagrams, c) Bode phase diagrams and d) equivalent electric circuit (EEC).

The polarization resistance (R_p) values obtained by the EIS method are consistent with the results obtained from the *LPR* method. Specifically, a lower R_p value was recorded for the solution containing dissolved corrosion products com-

pared to the pure standard solution, which is also reflected in Tables II and III. This reduction in polarization resistance is attributed to the moderate acidity present in the solution with dissolved corrosion products.

Furthermore, Fig. 11 indicates a relatively high electrolyte resistance (R_e), attributed to the low concentration of ions in the tested solutions. In contrast, the electrolyte resistance is lower in the solution with dissolved steel corrosion products due to the presence of hydrogen ions.

The Bode phase diagram further supports these observations, revealing that steel exhibits reduced corrosion resistance in the standard solution containing corrosion products (Fig. 11 c and Table III) compared to the pure standard solution. The narrowing of the peak at low frequencies reinforces this conclusion, along with a shift of the peak towards higher frequencies, consistent with the literature findings.⁴⁵

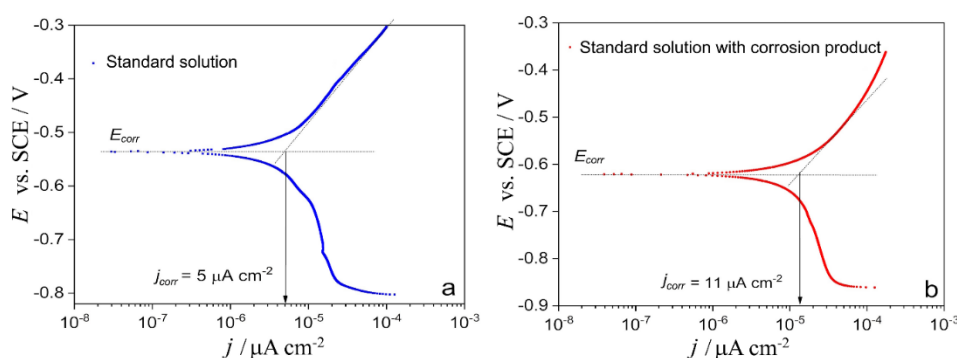
Linear sweep voltammetry (LSV) testing of steel (Fig. 12) revealed a higher corrosion current density (j_{corr}) in the solution containing dissolved corrosion products compared to the standard solution. Specifically, the j_{corr} value for steel in the solution with corrosion products was 11 μ A cm⁻², while in the standard solution, it was 5 μ A cm⁻². The corrosion rate values (v_{corr}) were then calculated using Faraday's law based on the measured j_{corr} values (Table IV).

These results demonstrate that the presence of corrosion products increases the corrosion rate, which is consistent with the findings from the LPR and EIS measurements. This increased corrosion rate is attributed to the acidic environment generated by akaganeite (β -FeO(OH)) and iron (II) chloride present in the corrosion products, according to Reaction (4).

Fig. 12. Results of testing steel by the Tafel method in: a) the standard solution and b) the solution obtained by dissolving corrosion products in the standard solution.
